DL12 Limit Assembly Gear Spacing

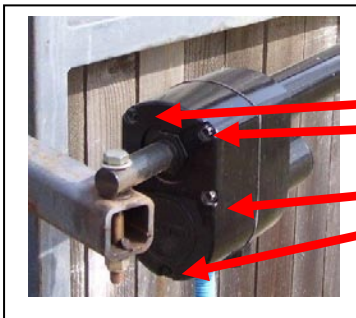
Five bolts holding rear cover 5/16
1 not shown

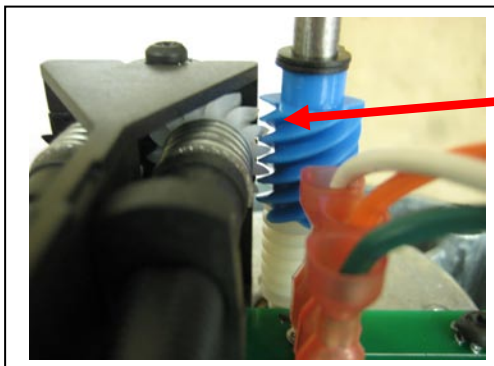
Problem description: If the open and close position are changing randomly when the gate is operated the possible cause can be limit assembly gear spacing. To inspect and adjust this follow the steps below.

The gap between the blue and white
gear

NOTE: Do not apply pressure to the limit assembly just slide over until space is reduced and tighten screw.

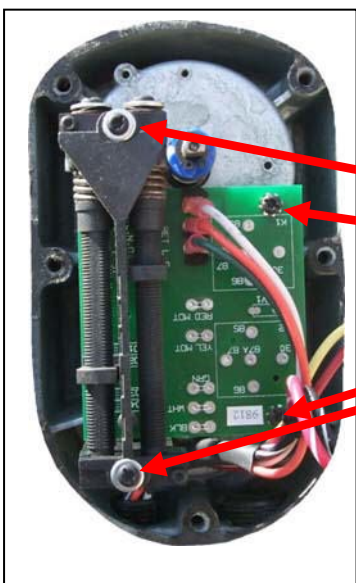
Loosen 4 screws

1. Disconnect the actuator cable from the control board.
2. Remove the 5 bolts holding the rear cover on the actuator. 5/16 head size.
3. Inspect the spacing between the blue and white gear.
4. Loosen the 4 screws to allow the limit assembly to slide over against the blue gear.
5. Once limit assembly white gear spacing is adjusted tighten the 4 screws.
