## DL12 Limit Assembly Gear Spacing

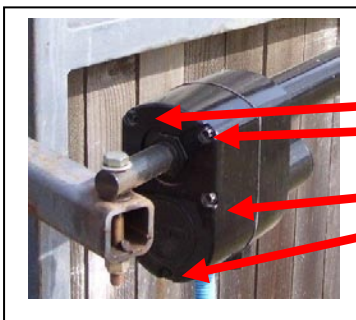
Five bolts holding rear cover 5/16  
1 not shown

1. Disconnect the actuator cable from the control board.
2. Remove the 5 bolts holding the rear cover on the actuator. 5/16 head size.
3. Inspect the spacing between the blue and white gear.
4. Loosen the 4 screws to allow the limit assembly to slide over against the blue gear.
5. Once limit assembly white gear spacing is adjusted tighten the 4 screws.

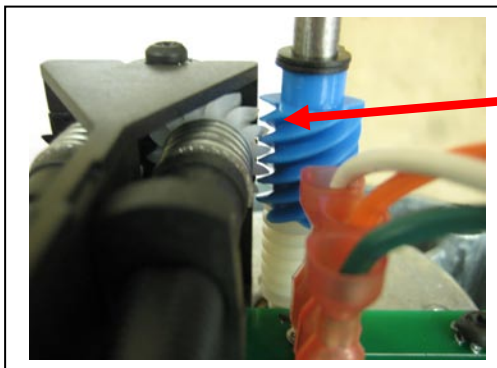
Problem description: If the open and close position are changing randomly when the gate is operated the possible cause can be limit assembly gear spacing. To inspect and adjust this follow the steps below.

The gap between the blue and white  
gear

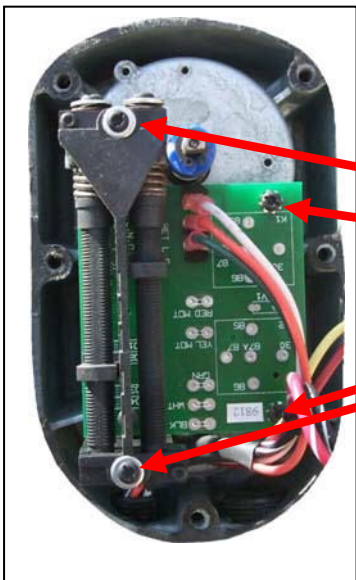
Loosen 4 screws

NOTE: Do not apply pressure to the limit assembly just slide over until space is reduced and tighten screw.
